Outsourcing and Accidents in the Electrical Sector

Alessandro José Nunes da Silva^a, Rodolfo Andrade Gouveia Vilela^b
and Ildeberto Muniz de Almeida^c

ABSTRACT

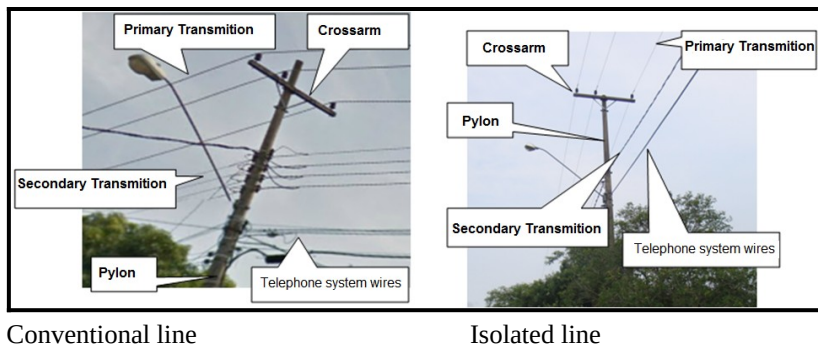
Although the interventions at the posts would be conducted by electricians, this maintenance work is done in proximity to the primary line energized and the activity to be performed is formally framed as civil construction. In conventional networks there is no maintenance programmed for the replacement of crossarms, so that the presence of degraded structures is common even in the aspect of their functioning, thus weakening the system since in the event of breakage due to *wear (and tear)* or deterioration of the wood, cables of the energized primary line would fall.

Figure 1. Primary and secondary lines in conventional networks (left side) and isolated (right side of the figure)

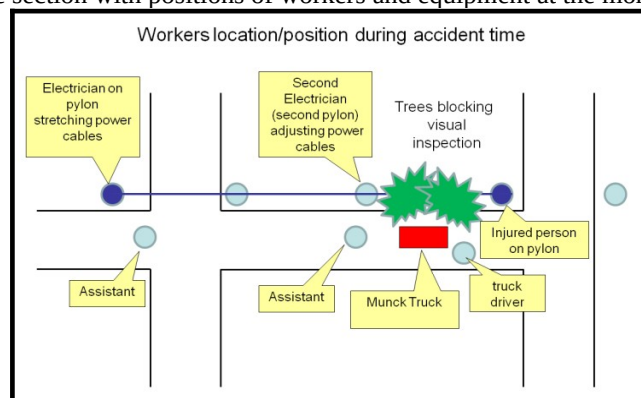
On the day of the accident, the team of Mr. “C” replaced cables inside a residential condominium. After the removal of the old line, at about 5:43pm, the electrician had begun the fixation of the cables onto the first post. The task was performed under time pressure since the presence of trees between the first and second pylons had delayed the team.

Figure 2 – Schematic of the section with positions of workers and equipment at the moment of the accident.

Up to the present, the analysis has had access to and considered two versions of the event. According to the first, when Mr. “C” had already partially grasped the new cable to be installed on the first post of the section, his work was affected by the intervention of team colleagues that, with the aid of the arm from the Munck truck, passed the same cable above the tops of the trees located between the first and second posts of the section. The tension to which the wiring was submitted had balanced the post on which Mr. C was positioned, breaking the crossarm situated slightly above the point where he was working and leading to the fall of the energized cable of the primary line onto his leg.

In second version, the cable being replaced had already been passed above the trees and was being pulled by the ratchet used by a fellow electrician that was on the fourth post situated at a distance. This electrician had not been advised that the cables were stuck in some branches of the trees. Assistants of the team acted to detach the cables from the branches, dissipating the tension by a curling movement reaching the first post several times and making it ascend so that the crossarm broke and knocked down the energized wire of the primary line.

Both versions have the same outcome: the breaking of the crossarm and the fall of the energized cable onto the body of Mr. "C". Upon perceiving the imminence of electric shock, the electrician tried to descend the ladder, released the first lanyard of the safety belt and jumped to the rear. However, he was trapped by the second lanyard and fell seated on the telephone cables situated slightly below. At this point the cable of the energized line (primary) struck the worker provoking electric shock that entered by the anterior facet of his left leg and exited in the region of the buttocks in contact with the telephonic wiring, thereby provoking very severe burns and subsequent amputation of the struck leg.
