Investigation of an Auto-Belay Failure Within an Indoor Climbing Gym

David Eager

University of Technology Sydney, PO Box 123, Broadway, NSW 2007, Australia

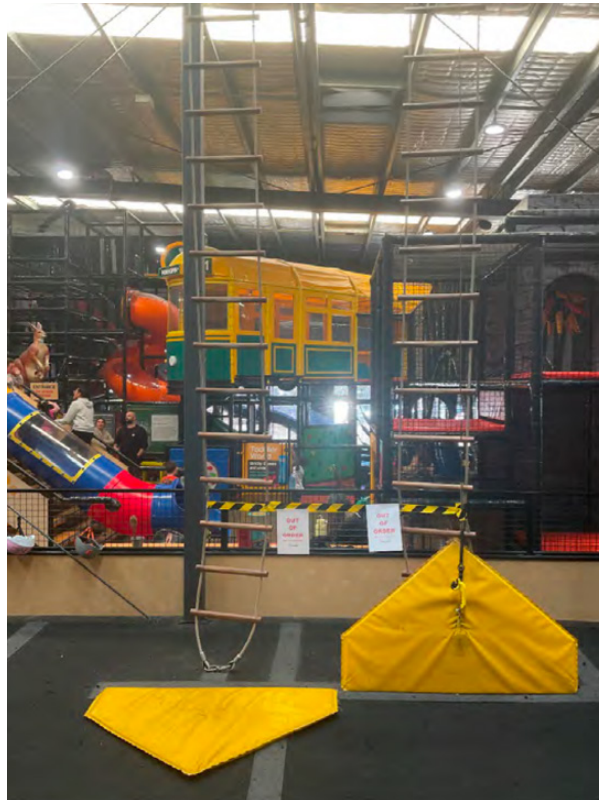
Figure 1 is a photograph taken depicting the configuration of the Commando rope-ladder climbs as they were after the incident. The injured party fell from the top of left-hand ladder which can be seen with the tape fully retracted to the ceiling and out of view.

Figure 1: Commando rope-ladder climbs depicting the tape of the left-hand ladder fully retracted to the ceiling [Eager, 2023].

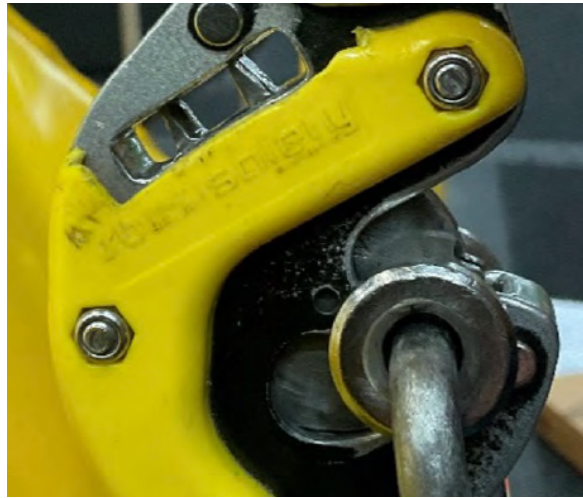
Excessive wear of the components within the Self-Belay Device allowed sufficient movement of the locking anchors for the device to malfunction (Figures 4 and 5).

A significant gap between the pins and locking anchors can be seen in Figure 5. The uncontrolled movement between the pins and locking anchors allowed the key to be removed when the worn connector was not fully engaged which allowed the participant to commence climbing while not secure (Eager, 2023).

Figure 4: Side view of the heavily worn Self-Belay Body which failed depicting the locking key being able to be removed when the Self-Belay Maillon connector was not fully engaged (Eager, 2025).

It was concluded that the incident was a direct result of inadequate maintenance. The indoor climbing gym operator was fined AUD60,000 and was also issued with a Court Order to pay costs.

It is critical for the safe operation of indoor climbing gyms that operators strictly comply with the manufacture instructions including scheduled maintenance instructions.

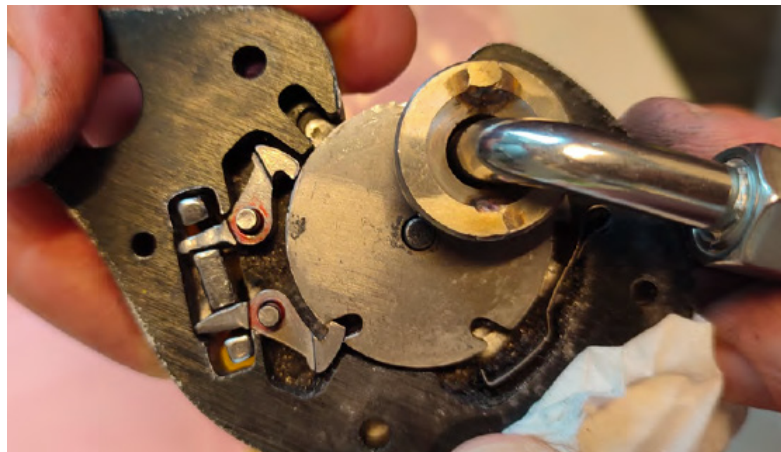
Figure 5: Disassembled and partially reassembled heavily worn Self-Belay Body which failed depicting a single locking anchors engaged within the worn Self-Belay Maillon connector partially engaged (Eager, 2025).

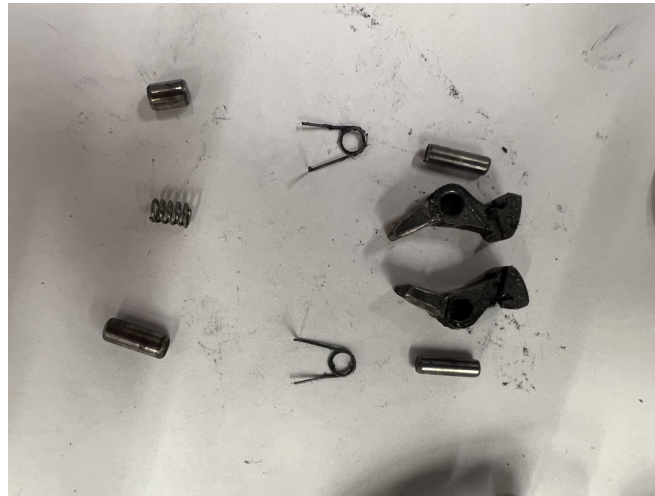
Figure 6 depicts the anchors and pins subcomponents within the Self-Belay Body before they were cleaned, measured and examined using an Olympus 3D LEXT laser microscope.

Figure 6: Self-Belay Body worn anchors and pins before they were cleaned, (Eager, 2023).

The analysed revealed that the locking lever holes were severely worn and that this wear allowed the device to malfunction.

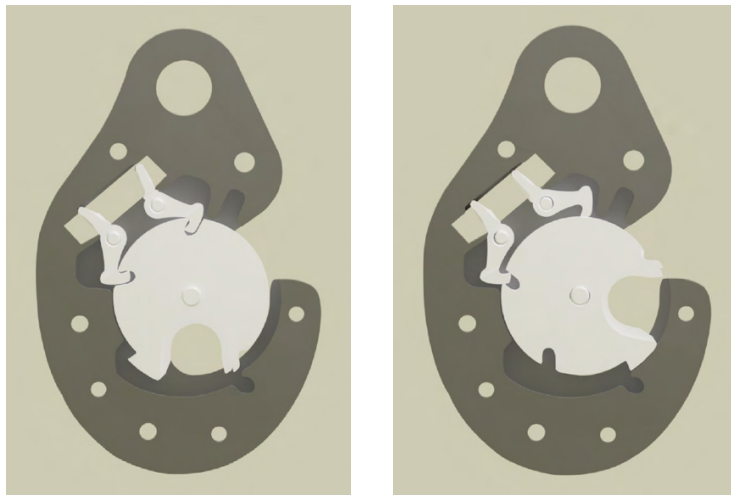
Figure 7 depicts a sectional view of the Self-Belay Body.

Figure 7: Sectional view of the Self-Belay Body: Right: depicting the twin locking levers engaging with the three locking disks as it was designed to operate; and Left: depicting a single locking lever prematurely engaged with the three locking disks before the locking disk have rotated to the locking position (Eager, 2025).
