An Illumination Study on Floating Storage and Offloading Vessel

Illumination Study at Floating Storage Offshore, East Coast Malaysia

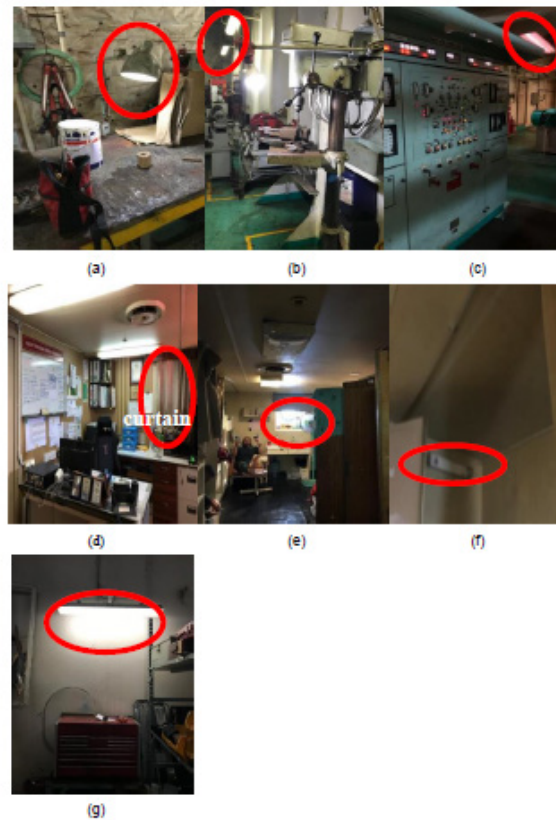
The first measurement was the general lighting carried out during the walkthrough inspection. Certain area such as in the workshops, have a combination of background lighting and localized/task lighting as shown in Figure 1(a) and (b). The task lights are adjustable and flexible, which allows for more visual comfort to the users while performing the specific detailing tasks. At several locations (i.e., near the boiler control panel as shown in Figure 1(c)), the fluorescent bulb for general lighting was removed and not replaced. Figure 1(d) showed a good practice where curtains were drawn to prevent glare. Figure 1(e) showed that one of the bedrooms (Room T) lacked general illumination due to blown bulbs. Occupants relied on natural lighting from the window for illumination. This can create a safety hazard (i.e., slip, trip, and fall, especially at nighttime). Inside certain bedrooms, as illustrated in Figure 1(f), the reading lights were not installed after being removed. At most of the storage areas, as shown in Figure 1(g), localized lightings were adopted due to the condition of the work areas.

Figure 1: Walkthrough inspection from points (a) to (g) covering the office, reception, and storage.

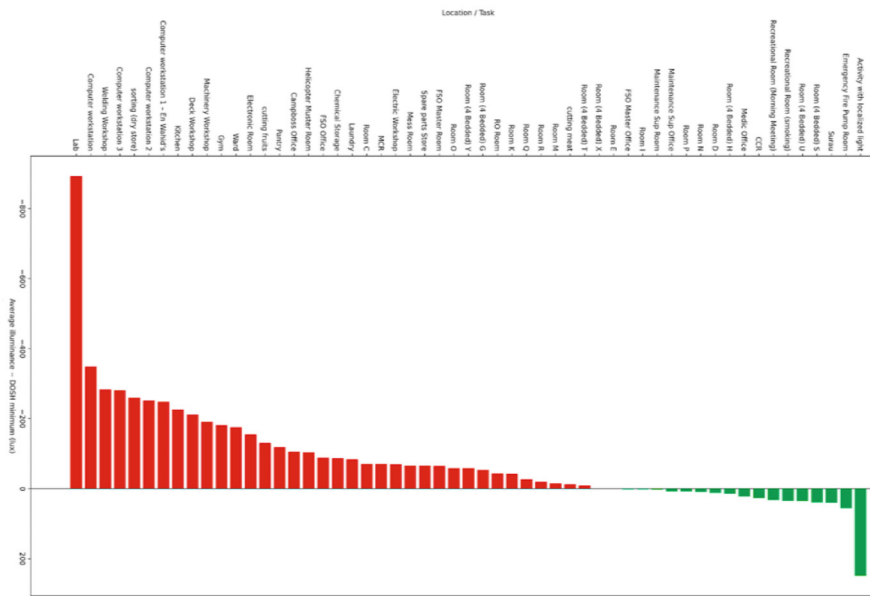
The detail result of the specific task/ activity are in the Appendix. Twenty (20) out of forty-eight (48) locations meet the average minimum recommended illumination (100 to 843 lux). All desktop activities at the studied locations did not achieve the minimum recommended illumination levels, with the lowest measurement at 51lux from Deck 1 (gaps from the Guidelines' required lux between -70 to -349). As for activities inside the workshops, specific tasks are supplemented with task lights. Due to this, the specific activities were found to meet the minimum illumination recommendation based on the activities performed, even though the general lighting of each workshop was found to be below the recommended illumination level. The gap-to-standard, obtained by subtracting the DOSH (2018) minimum illuminance requirement from the measured average lux. As illustrated in Figure 2, the red bars indicate locations that did not meet the required lighting levels.

Figure 2: Gap- to-Standard by location/task.
