# 3M Poland Manufacturing: An Ergonomics Success Story

## CASE STUDY 1: JANINOW FEMA LINE - AUTOMATIC TURNOVER OF SCOURERS

## CASE STUDY 2: RABKA - MIXING AREA

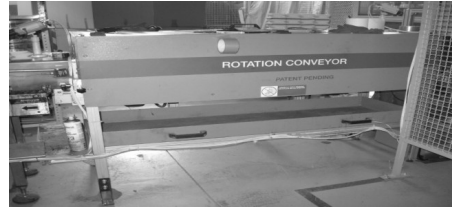
Figure 3: New, Automated Machine

A multidisciplinary team, including a production engineer, project engineer, MU supervisor, and external company designers, worked to improve the equipment and eliminate the identified unacceptable WMSD risk exposures. It was decided that, due to the potential for wrist strain injury in the execution of this task, it was a priority to eliminate the manual process and design an automatic station to turn over the scourers.

To verify the automation changes were effective at eliminating the unacceptable WMDS risk exposure, a new EJA assessment was completed. The assessment results indicated that the unacceptable risks for the operator from this line were eliminated by 80% (wrist flexion, repetition, mechanical stress to arms, hand palm down and neck flexion) and productivity was increased by 70%. Now the speed of the automatic conveyor is the same as the maximum speed of the whole line.

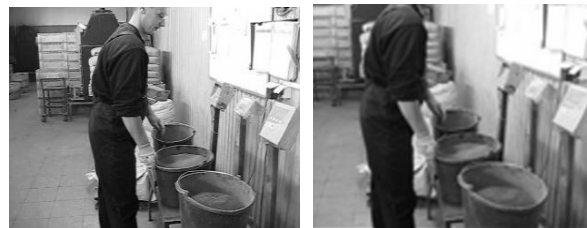
Figure 4: Weighing and transporting resin into mixer - 38kg per bucket

As with the first case study, this project also was identified and prioritized using the ERRP: a workstation at the manufacturing area had employee complaints about the difficult work. The EJA resource applied the EJA to identify the unacceptable risk exposures, which corroborated the employees' complaints about lifting and carrying. Before the improvements, all the lifting and carrying tasks in the mixing were manual. There were three tasks in the mixing area that, when combined, resulted in an employee lifting and carrying over 9,000 kg each shift. The first task was transporting the resin in bags, which was delivered from a warehouse into the production area to the mixer; the second task was loading chemicals into the mixer; and the third task was transporting the material to the storage compound. Reducing or eliminating the lifting and carrying of the very heavy buckets weighing over 38 kg was the most important and critical issue for the Ergonomics Team (see Figure 4).

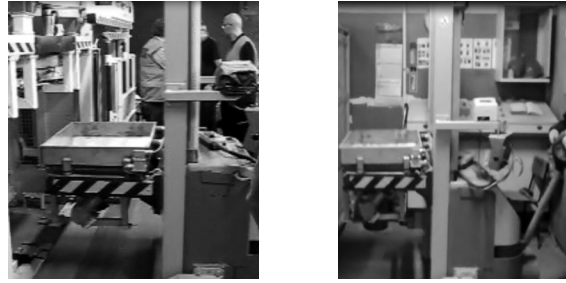
Figure 5: Weighing and transporting resin into mixer using electrical forklift truck with scale

The first improvement was to use an electric truck with an embedded scale to eliminate the manual lifting of buckets to weigh the material. This change also made it easier to transport the resin from the mixing area to the press and facilitated the dumping of resin into the mixer. The new process is performed in one step by electric truck and eliminated three manual operations previously performed by an employee using buckets. Additional benefits were increased capacity and more accurate direct weighing of resin to the container as seen in Figure 5, thereby increasing process consistency and improving product quality.

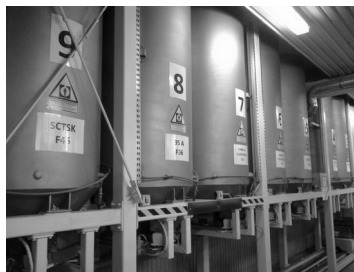
Figure 7: Silos and automatic storage compound system

The third improvement focused on eliminating the existing storage system and installing a new, fully automated storage system, as shown in Figure 7. The new system eliminated lifting of containers from the floor and reduced the floor space needed for the operation.
