Human Factors Safety Management Issues in Marine and Pipeline Investigations

Derek Johnston, Anne Garcia, and Sara Lyons

National Transportation Safety Board, Washington, DC 20594, USA

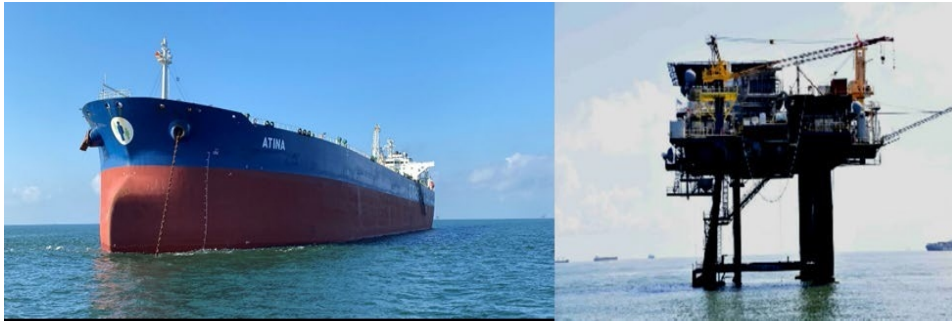
Figure 1: *Atina* shown postcasualty (left) and platform SP-57B shown precasualty (right) (NTSB, 2021).

On October 17, 2020, at 0446 local time, the 898-foot-long tanker *Atina* was preparing to anchor in the Southwest Pass Fairway Anchorage in the Gulf of Mexico with 21 crewmembers onboard, about 21.5 miles from Pilot-town, Louisiana. During the maneuver, the tanker's bow struck the manned oil and gas production platform SP-57B. There were no injuries or pollution reported, however damages to the platform and vessel were estimated at \$72.9 million.
