Subjective Evaluation of Identifying Boundaries of Railroad Crossing by the Visually Impaired Based on Walking Experiment

ABSTRACT

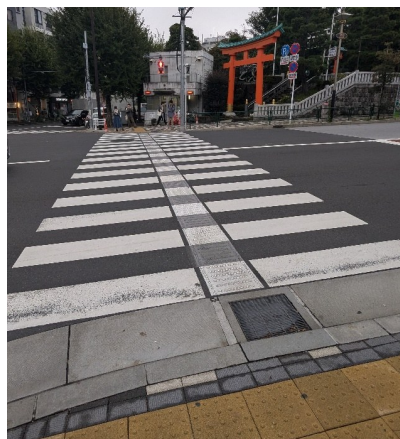
Figure 2: Escort zone.

In Japan, various safety facilities, such as Tactile Walking Surface Indicators (TWSI), escort zones, and acoustic traffic signals, have been installed to assist visually impaired individuals in walking outdoors (Figs. 1 and 2). Similar safety measures have also been implemented at railroad crossings; however, insufficient consideration has been given to the walking characteristics of visually impaired individuals and the scales of railroad crossings. In April 2022, an accident involving a visually impaired person occurred at a railroad crossing in Nara Prefecture. The misidentification of the inside and outside of the railroad crossing was identified as a new cause of accidents

involving visually impaired individuals. In response, the Ministry of Land, Infrastructure, Transport and Tourism (MLIT) revised the “Guidelines for Universal Design of Roads” twice following this accident (MLIT, 2024). These revisions introduced specific standards for safety measures at railroad crossings, including the installation of dot blocks in front of the crossings. Additionally, the guidelines specified the use of guide projections inside the crossings, which differ from the TWSI and escort zones (Fig. 2).

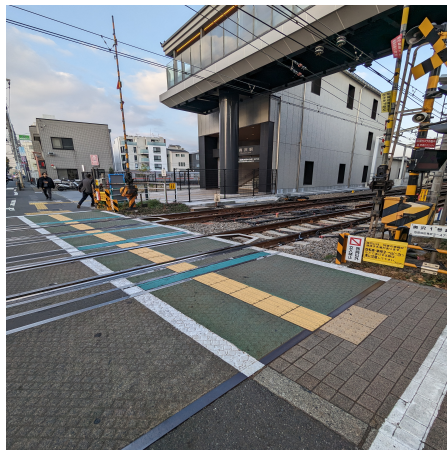
Figure 3: The railroad crossing near Okusawa station.

Before these guideline revisions, TWSI had already been installed inside a railroad crossing near Okusawa Station in Setagaya City, Tokyo, to assist visually impaired individuals in walking safely (Fig. 3). This measure has been positively evaluated for its effectiveness in preventing deviations toward roadways or ballasts. However, because the TWSI installed inside the crossing is identical in shape to that on the sidewalks, there is a risk of misidentification between the inside and outside of the crossing, as observed in Nara Prefecture.

The railroad crossing near Okusawa Station extends in a north–south direction and is approximately 7 m long. The width of the pedestrian area is approximately 2.4 m. This is the only known case in Japan where TWSIs have been installed inside a railroad crossing.

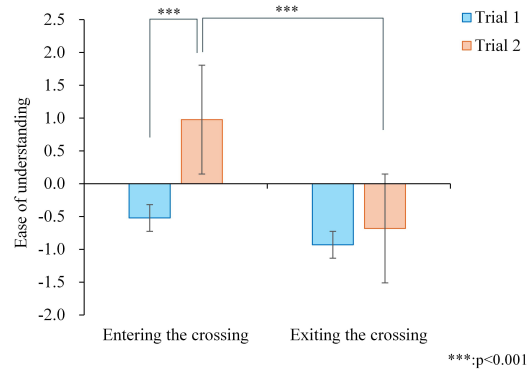
Figure 6: Evaluation results of “ease of understanding the boundaries between the inside and outside of the railroad crossing”.

The evaluation results for the "ease of understanding the boundaries between the inside and outside of the railroad crossing" by the 11 participants are shown in Fig. 6. An analysis of variance (ANOVA) with "Trial," "Crossing Direction," and "Entering the crossing (Enter)/Exiting the crossing (Exit)" as factors revealed a main effect for "Trial" and "Enter/Exit" at significance levels of 1% and 0.1%, respectively (Table 1). Furthermore, a significant interaction between "Trial" and "Enter/Exit" was observed. A multiple comparison using the Tukey method revealed a significant difference in Trial 2 between entering and exiting the crossing ($p < 0.001$), as well as in entering the crossing between Trials 1 and 2 ($p < 0.001$).

This result is thought to reflect the influence of the absence of clear landmarks at the boundaries of the crossing and the continuous installation of TWSI from the inside to the outside of the crossing (Figs. 7 and 8). In Trial 2, where walls and fences were used outside the crossing, the evaluation score for the exit was low. This may be due to the TWSI inside and outside the

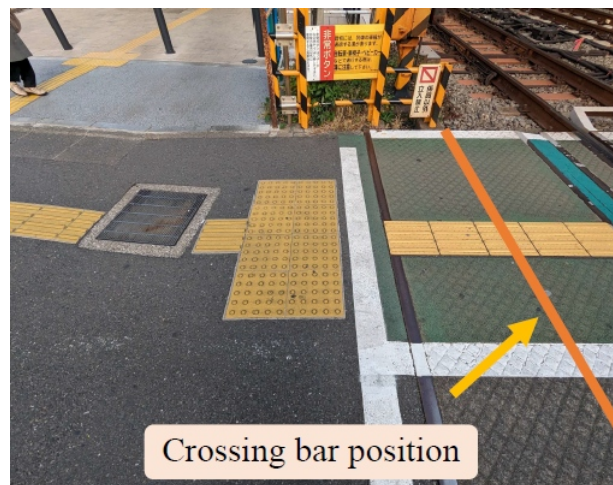
Figure 7: Condition of the railroad crossing boundary (north side of the crossing).

crossing having the same shape, which made it challenging to distinguish the walking distance at the crossing. Additionally, the dot blocks at the crossing boundaries and the bar blocks inside the crossing were installed without spacing, which is likely another factor influencing the clarity of the crossing boundary.
