# An Observation on the Accessibility of a Connecting Ramp Between Campus Buildings

Zhi-Hao Shou and Chien-Hsiung Chen

Department of Design, National Taiwan University of Science and Technology, Taipei 106335, Taiwan

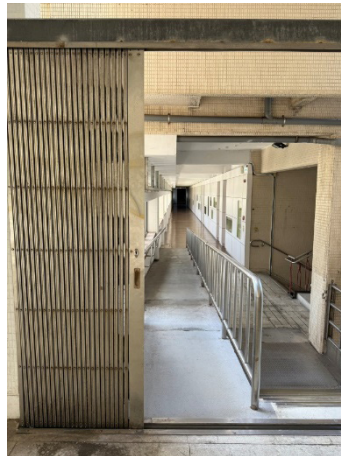
**Figure 3:** Current state of the ramp entrance.

Field data reveals that while the 1:12.3 gradient satisfies the 1:12 limit, the ramp violates Article 206.2.3 by omitting the required intermediary landing for its 88 cm rise. This absence forces users to endure excessive physical strain over the 1,082 cm distance. Furthermore, although the designed width is 100 cm, a retracted iron gate reduces the actual clear width to 68.5 cm, which is far below the 90 cm statutory minimum. Consequently, the ramp fails core benchmarks for both height management and passage width.

1. **Facility Remediation:** Replace entrance gates with sliding mechanisms to restore statutory clear width. Ramps must be updated to include intermediary landings, continuous bilateral handrails with 30 cm extensions, and high-contrast tactile surfaces. Optimized lighting is also required to ensure nighttime safety.
2. **Network Integration:** Establish a horizontal link between Buildings 1, 4, and the RB building to eliminate functional isolation. Feasibility studies should evaluate connecting platforms or shared elevators to integrate the Department of Design's activity zones into a continuous, accessible loop.
3. **Strategic Distribution:** Redistribute restrooms and wayfinding based on usage frequency. Specifically, the fourth floor of Building 4 requires an accessible restroom retrofit and enhanced signage to resolve service gaps.

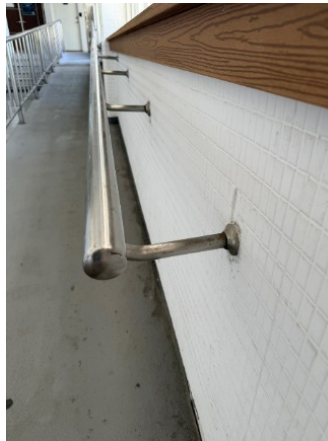
**Figure 4:** Current state of the ramp handrails.

The handrail height is approximately 70 cm (see Figure 4), which falls at the lower limit of the regulatory range. Both handrails are constructed from metal pipes; the left handrail extends continuously to the end of the ramp, while the right handrail terminates at the turn, where the final segment interfaces with the wall. Notably, no intermediary landings are installed on either side of the ramp, resulting in a single continuous incline across the entire section. The floor is finished with a slip-resistant cement coating;

Handrail height is approximately 70 cm, meeting only the lower regulatory limit. While the left handrail is continuous, the right side terminates abruptly at a turn, violating the requirement for bilateral continuity. This interruption compromises user balance and reduces the sense of security during descent. Furthermore, the handrails lack the mandated 30 cm extensions and terminate directly at the structural wall. These issues are compounded by the grey anti-slip coating's poor visual contrast and insufficient nighttime lighting, which pose significant risks for users with low vision.

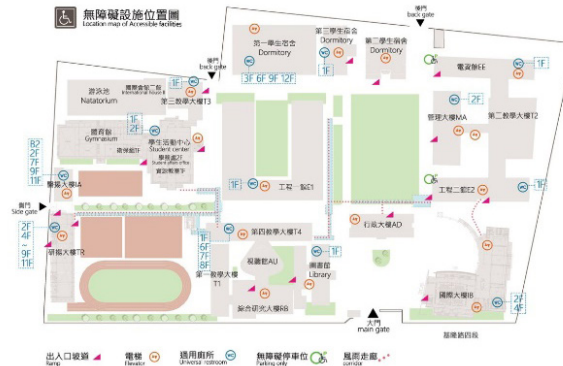
**Figure 6:** Accessible facility layout.

According to the accessible facility layout shown in Figure 6, accessible restrooms in Building 4 are situated on the first, sixth, seventh, and eighth floors, leaving the fourth floor without such facilities. This forces users to traverse multiple levels for basic facilities, presenting a significant logistical

burden. Despite regulations emphasizing distribution based on usage frequency, the absence of facilities on a major instructional floor highlights a hierarchical gap in campus accessibility planning.
